Appendix

Stormwater Management Plan: Inventories

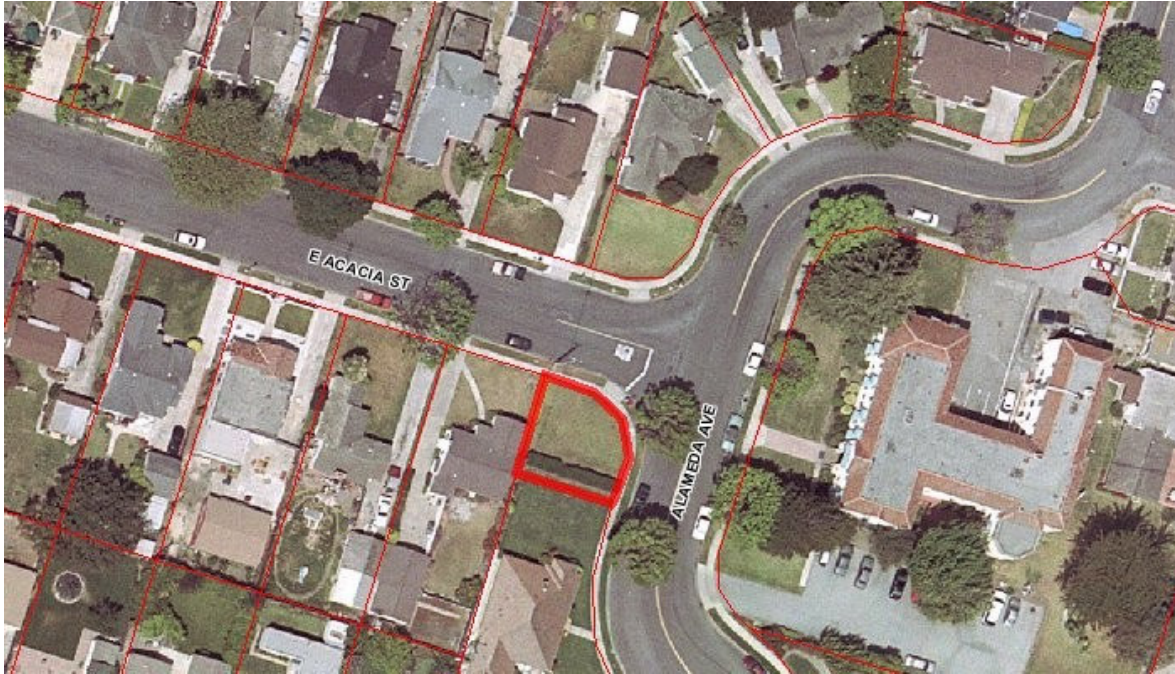
M001 ACACIA CORNERS

Acacia Corners is comprised of two sections of turf adjacent to houses on opposite sides of E. Acacia St. The sites have no structures, facilities, or recreational activities.

Potential site pollutants are sediment, nutrients, trash, bacteria, organics, pesticides, and oxygen demanding substances. These materials result from grounds or landscape maintenance. The site is level, permeable, has no onsite storm drains, and does not contribute significant pollutants of concern to the storm-water drainage system.

Current park maintenance procedures, as described above and in BMPs SC-10, 34, 41, 71, and 73, are effective at controlling pollutants. Additional BMP are not required at this site.

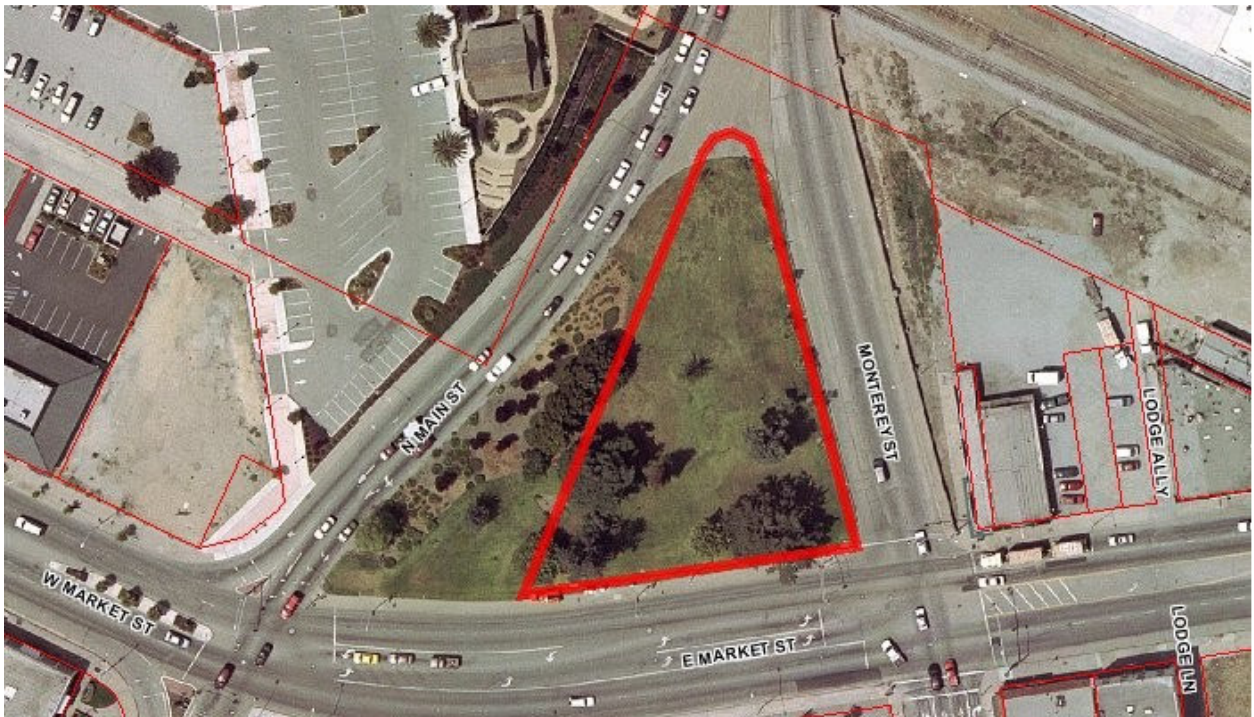
M002 BATAAN MEMORIAL PARK

Bataan Park has no structures, but consists of turf, mature trees, and landscape shrubs. The site is used for passive recreational activities only. Three major thoroughfares: W. Market Street, North Main Street, and Monterey Street border the park. The surrounding land is primarily commercial.

Potential pollutants from this site include nutrients, trash, bacteria, organics, pesticides, and oxygen demanding substances. These materials result from grounds or landscape maintenance and recreational day use. Storm and irrigation water is filtered through the permeable turf and/or landscape surfaces or flows to unprotected street drains at the lower tip of the sloped site. The site is cleaned daily for trash. Since the City is applying IPM techniques and does not apply chemical fertilizers, pollutants from this site are not a threat to downstream receiving water bodies.

Current park maintenance procedures, as described in BMPs SC-10, 34, 41, 71, 73, and 75 are effective at controlling pollutants. Additional BMPs are not required at this site.

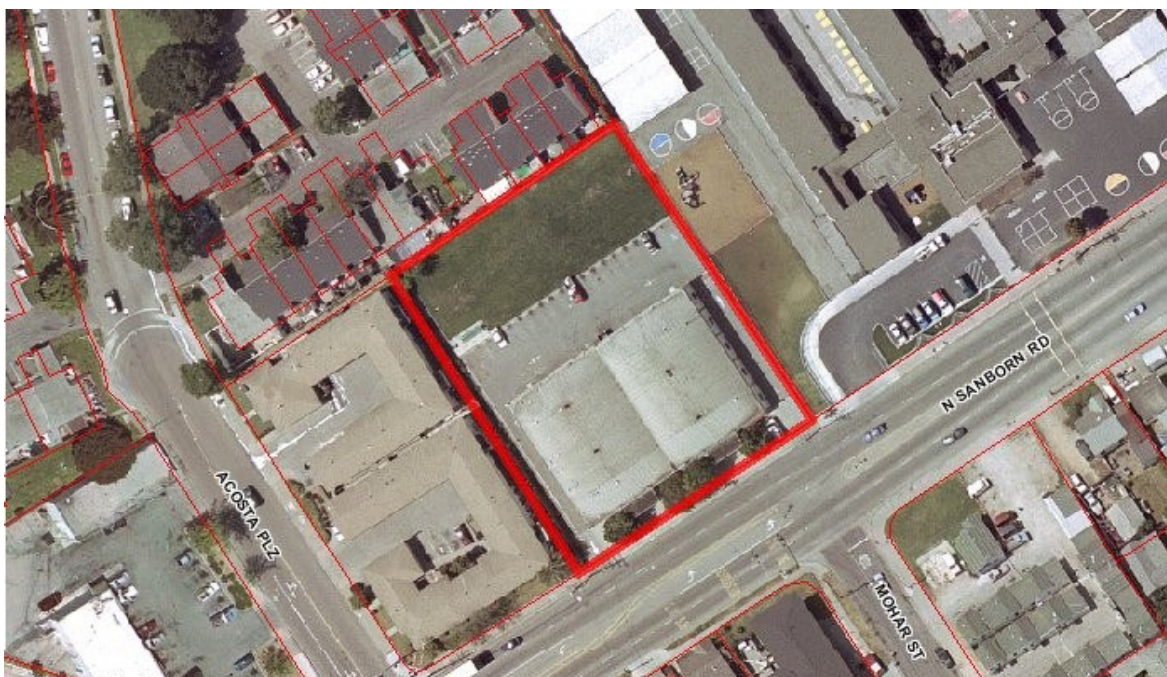
M003 BREADBOX RECREATION CENTER

Breadbox Recreation Center includes a building used for sport, game, and recreation activities, a parking lot, small turf area, and a barbeque/picnic site. There are businesses on N. Sanborn Drive on the south side. The east side is a school site. The north and west of the facility are residential homes and apartments.

Potential site pollutants are sediment, nutrients, trash, metals, bacteria, oil & grease, organics, pesticides, and oxygen demanding substances. These materials result from building, grounds, and landscape maintenance, recreational day use, and vehicular use of the parking lots. The site is over 70 % impervious surface, including the building and parking lot. The building drains to the side roads, parking lot, and front hardscape. The front hardscape drains to N. Sanborn Dr. and offsite street drains. The parking lots and driveways flow to gutters leading to a culvert in the west side of the rear parking lot. This culvert then flows to Acosta Plaza St. drains.

Current park and facility maintenance procedures, as described in BMPs SC-10, 11, 34, 41, 43, 71, and 73 are effective at controlling pollutants with the exception of those related to parking lots and driveways, which flow into unprotected street drains. In addition to the BMPs listed, all park and facility sites with parking lots will be included on a regularly scheduled sweeper route.

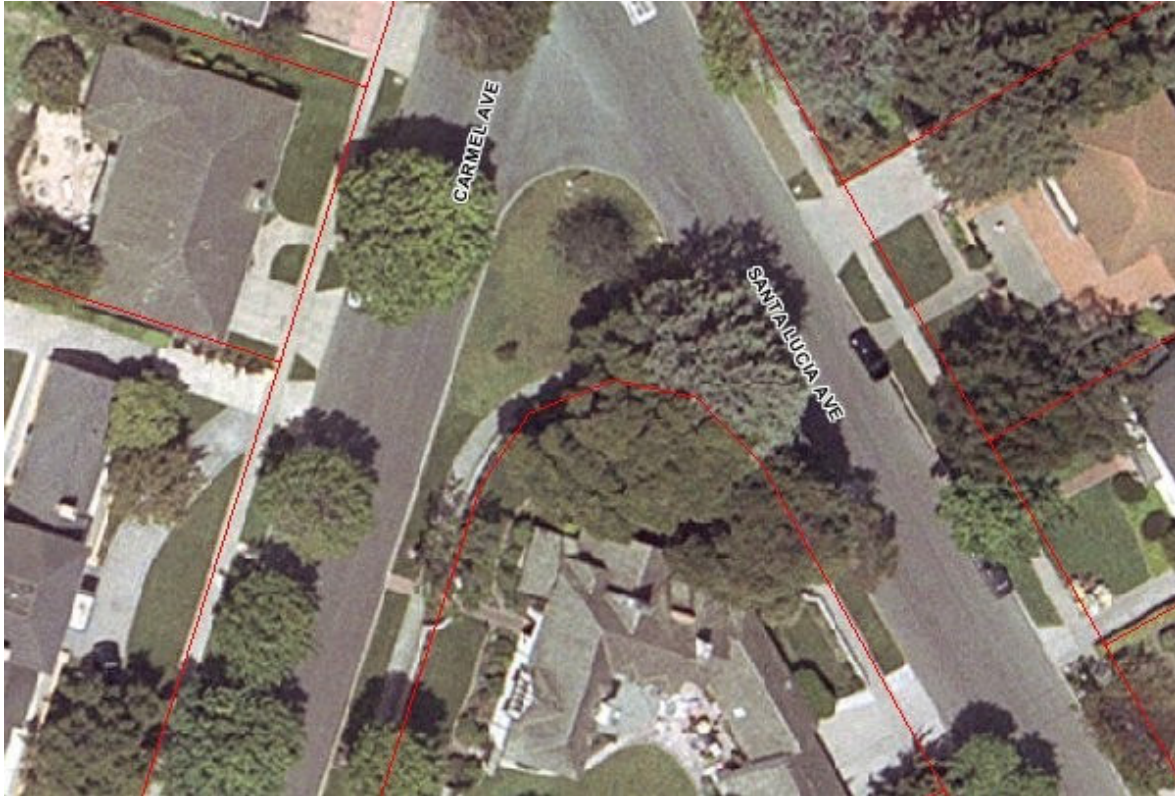
M004 CARMEL CORNER

Carmel Corner is a small, irrigated turf site on a residential street and has no facilities, structures, or recreational activity.

Potential site pollutants are sediment, nutrients, trash, bacteria, organics, pesticides, and oxygen demanding substances. These materials result from grounds or landscape maintenance. The site is level, permeable, has no onsite storm drains, and does not contribute significant pollutants of concern to the storm-water drainage system.

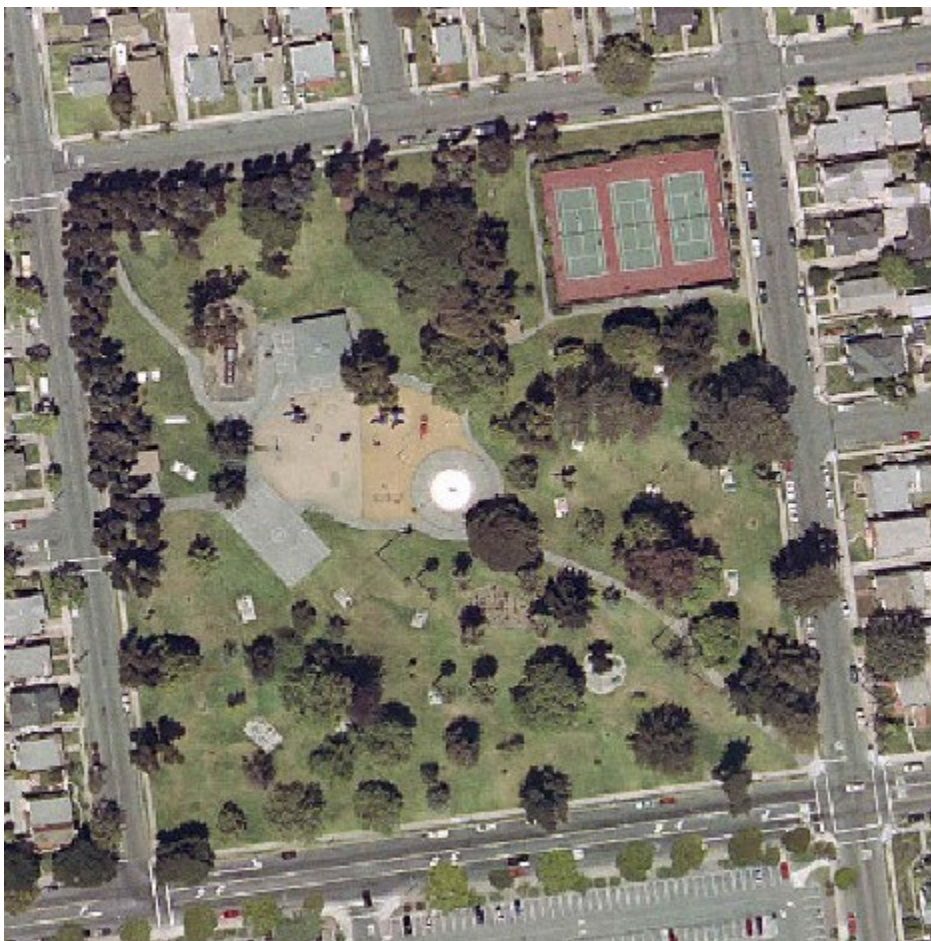
M005 CENTRAL PARK

Central Park is an 8-acre community park including tennis courts, two playgrounds, a wading pond, 16 picnic pads, a basketball court, and large areas of turf, mature trees, and landscape beds. There are four buildings including maintenance, recreation, restroom, and an irrigation pump house. Land use to the north, east, and west is residential. Hartnell Community College is on the south side.

Potential site pollutants are sediment, nutrients, trash, bacteria, organics, pesticides, and oxygen demanding substances. These materials result from grounds or landscape maintenance and recreational day use. The park is one of six sites with large picnic and barbeque areas that are heavily used on weekends, holidays, and for special events. These activities generate large amounts of garbage and litter. The trash is not a threat to storm water runoff because the city has staffed the weekends and holidays with personnel dedicated to cleanup of all park facilities and with special attention to the major parks, including Central Park. The park is level, well maintained, and storm and irrigation water are directed to permeable turf, playground, and landscape areas where

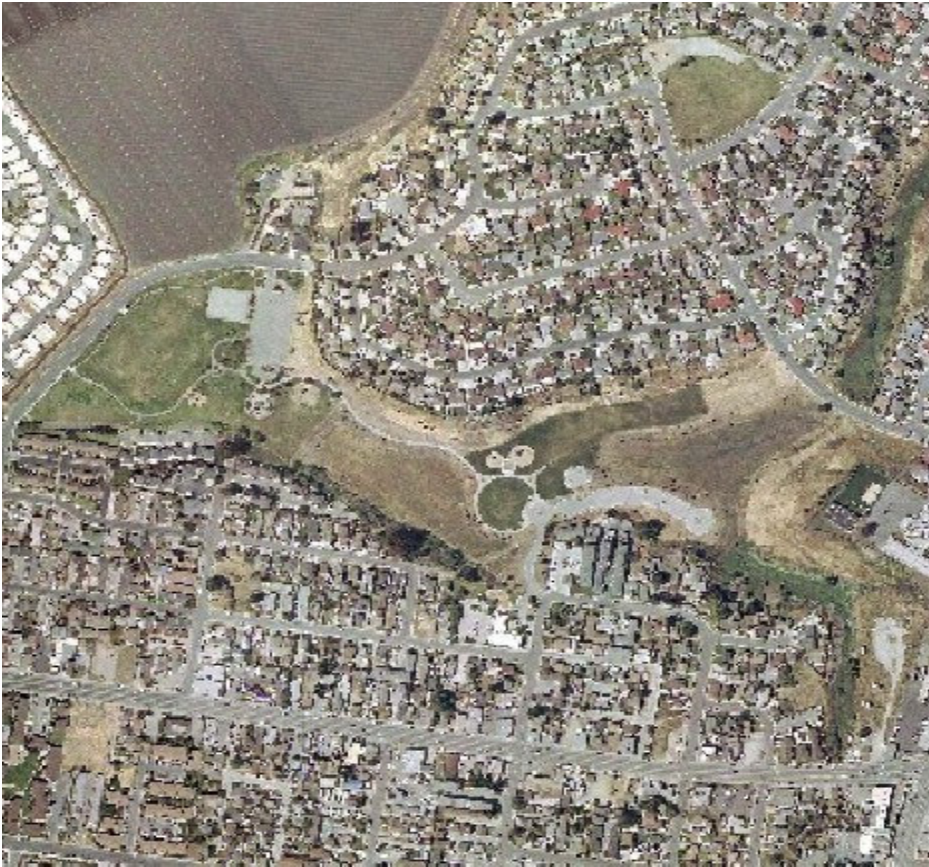
Cesar Chavez Community Park is a 28-acre multiuse facility that is split into two parcels, commonly called phase I and Phase II. The park is situated between N. Madeira to the west and Circle Drive to the east. Residential housing borders the park to the north and the south. Phase two is considered a riparian habitat area that is fed from street and stormwater runoff resultant from the surrounding residential housing. There are three detention basins built along the full expansions of the two park parcels. The park is situated within the 100-year floodplain, but it floods each winter. The park runoff flows into the Carr Lake reclamation ditch that exits the park at the Northwest end of the park, off of N. Madeira.

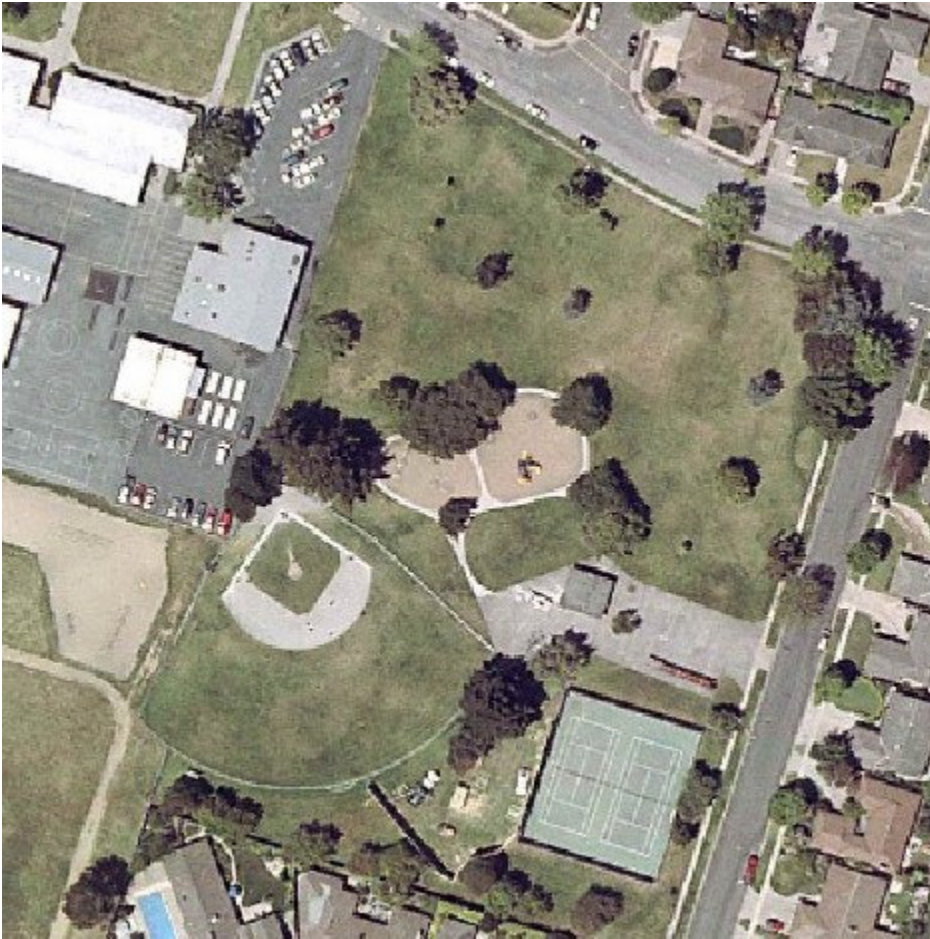
M007 CLAREMONT MANOR NEIGHBORHOOD PARK

Claremont Park is a 5-acre multiuse facility with a recreation building and attached restrooms, tennis courts, a basketball court, baseball field, and a large turf area with two picnic pads. There is a fenced California Water Service Company well enclosure in the southeast corner. The park is adjacent to an elementary school on the west and the other three sides are residential areas.

Potential site pollutants are sediment, nutrients, trash, bacteria, oils and greases, organics, pesticides, and oxygen demanding substances. These materials result from grounds or landscape maintenance operations and recreational day use. The park is approximately 13 % impervious surface. The building drains to the asphalt pad and these areas drain to surrounding permeable turf, landscape, and playground areas to percolate. The park is level and there are no storm drains on site. Pollutants generated by park activity do not enter the storm water system. The Cal Water pump system is well-maintained, is located on a permeable soil base in a turf area, and does not contribute to storm water pollution.

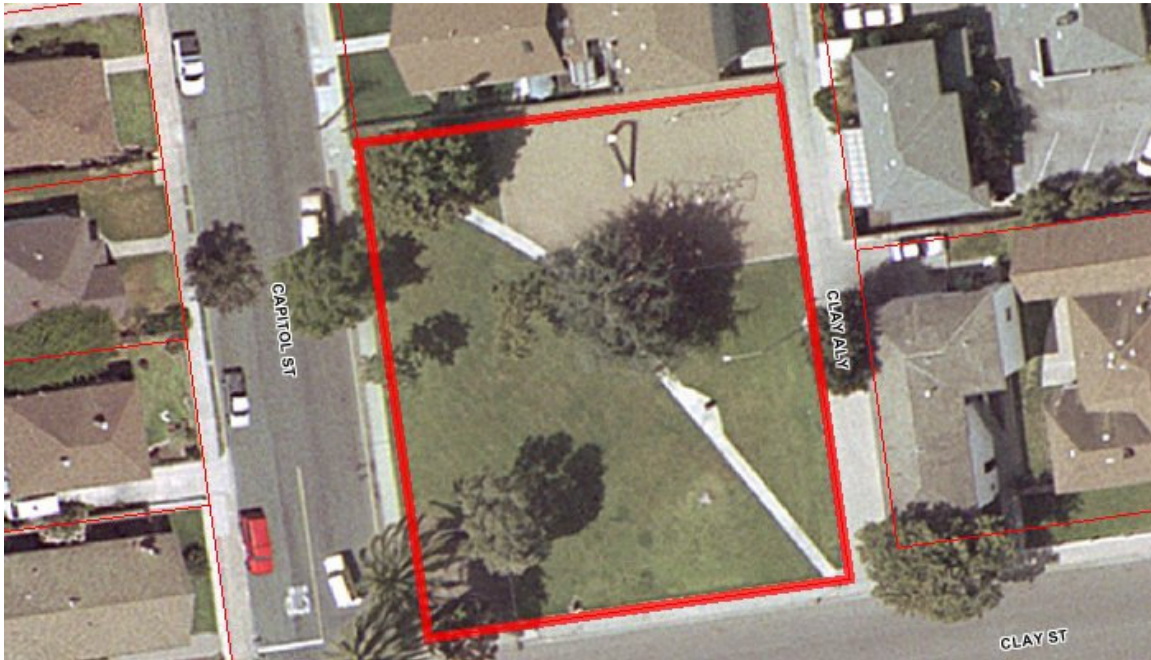
Clay Street Park is a .5-acre neighborhood park with a playground, small turf area, and landscape areas with trees. Residential areas surround the park.

Potential site pollutants are sediment, nutrients, trash, bacteria, organics, pesticides, and oxygen demanding substances. These materials result from grounds or landscape maintenance and recreational day use. There is one concrete path with a picnic table pad that drains to permeable turf and playground areas. There are no storm drains or other impervious surfaces in the park. Pollutants generated by park activity do not enter the storm water system.

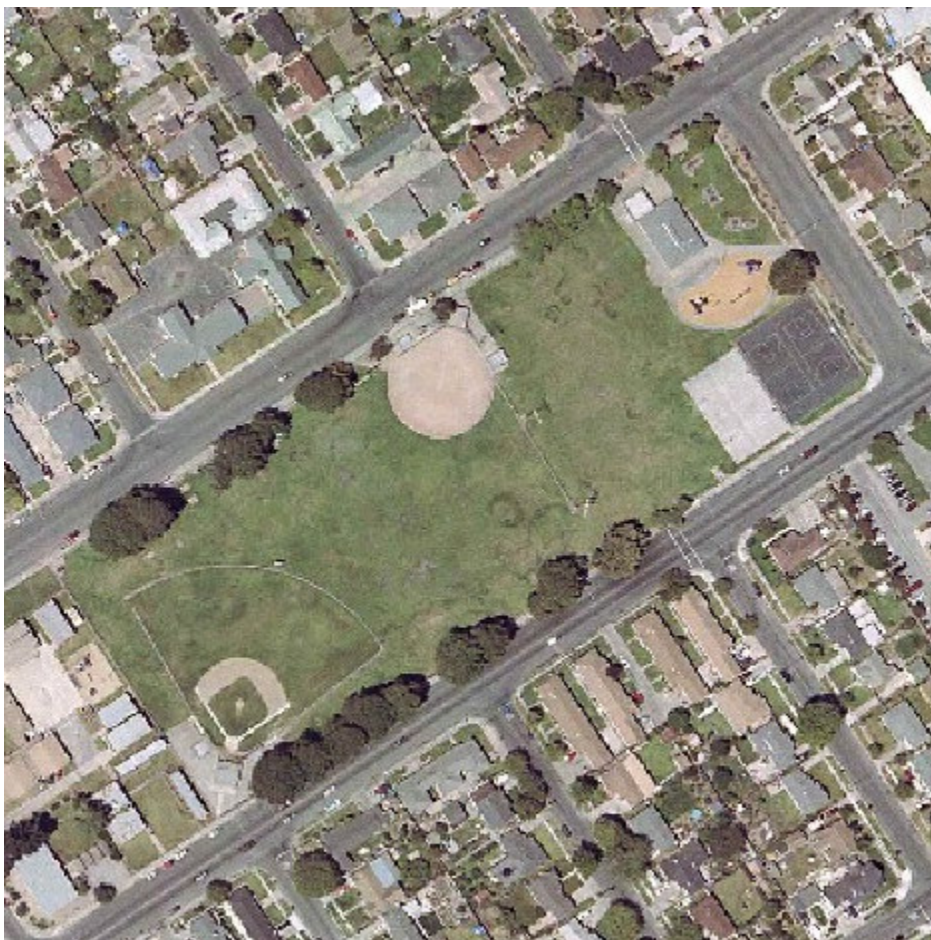
Closter Community Park is a 7 acre multiuse facility. It is located on the corner of Towt Street and Dewey Avenue and is bordered by residential streets on three sides and a daycare facility located at the southwest end of the park.

The park is approximately 10% impervious hardscape, include a, a recreation center and maintenance building, a restroom building, (2) asphalt basketball courts, (2) concrete basketball courts and (3) concrete picnic pads. Other park facilities include a baseball field, softball field, horseshoe pits, a sand playground and a multipurpose turf area. The park is bordered by monolithic concrete sidewalks on three sides that drain to either the turfgrass or the street. The buildings drain off onto asphalt walk paths which then either evaporates or drains to the turf for filtration.

Park staff wash the concrete BBQ area with water and biodegradable materials that evaporates or drains to the turf for filtration. All parking for park activities is on the surrounding City streets.

Current park and facility maintenance procedures, as described in BMPs SC-10, 11, 34, 41, 43, 60, 71, 73, and 75 are effective in controlling pollutants. Litter and garbage are picked up daily and landscape debris such as leaf matter is mulched by the mowing operations weekly. Obvious spills or hazardous vehicle waste products found on the curbs and streets are removed at the time of observation.

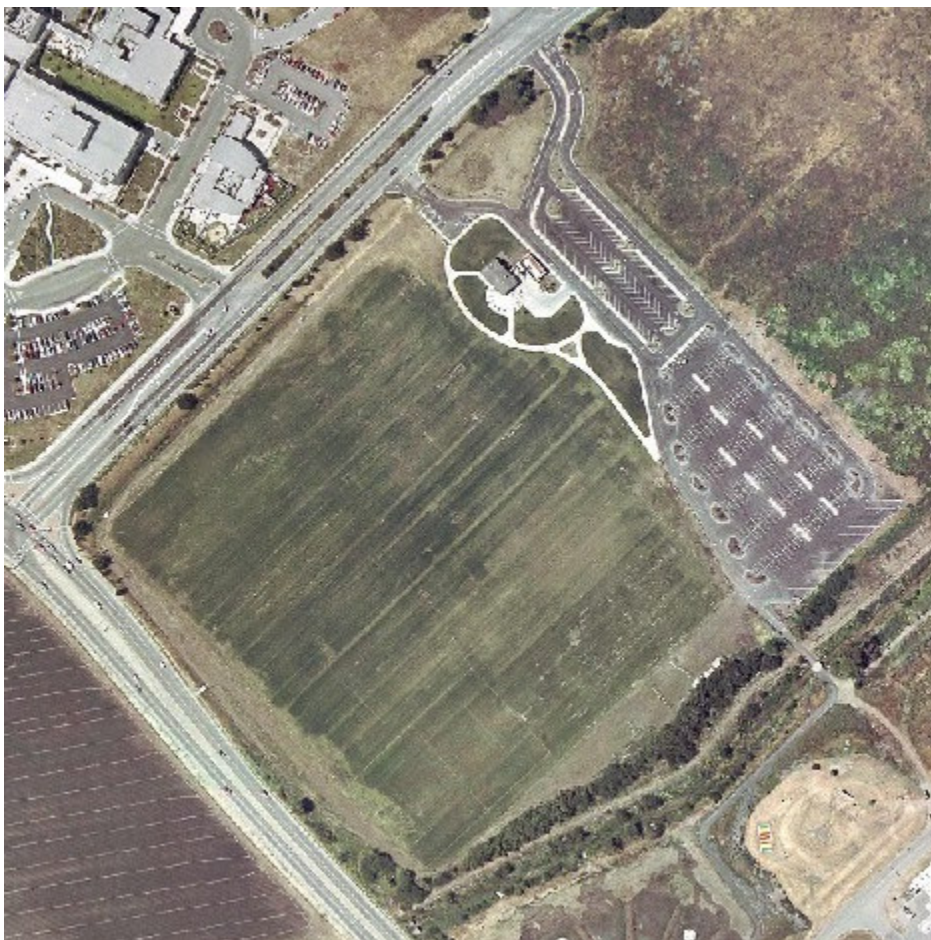
Constitution Soccer Complex is located at the corner of E. Laurel Drive and Constitution Blvd. It is a 15.94 acre, single use, soccer facility with 11 fields of various sizes. There are 4.5 acres of open space including a new recycled concrete/asphalt service road that circle the turf area. The restroom/concession building includes a maintenance garage, an equipment storage closet, two exterior concrete equipment storage areas, and an outdoor picnic area.

Potential site pollutants are sediment, nutrients, trash, metals, bacteria, organics, pesticides, and oxygen demanding substances. These materials result from grounds or landscape maintenance and heavy recreational day use. Additionally, materials of the same nature enter the drainage ditch from normal street usage and maintenance activity. The park is approximately 25% impervious surfacing, consisting of 5.6 acres of asphalt parking lot and concrete walkways. There are no stormdrains located within the parking lot so all runoff drains onto dirt openspace on either side of the parking lot and percolates into the groundwater system. The sports field slopes gradually to a drainage

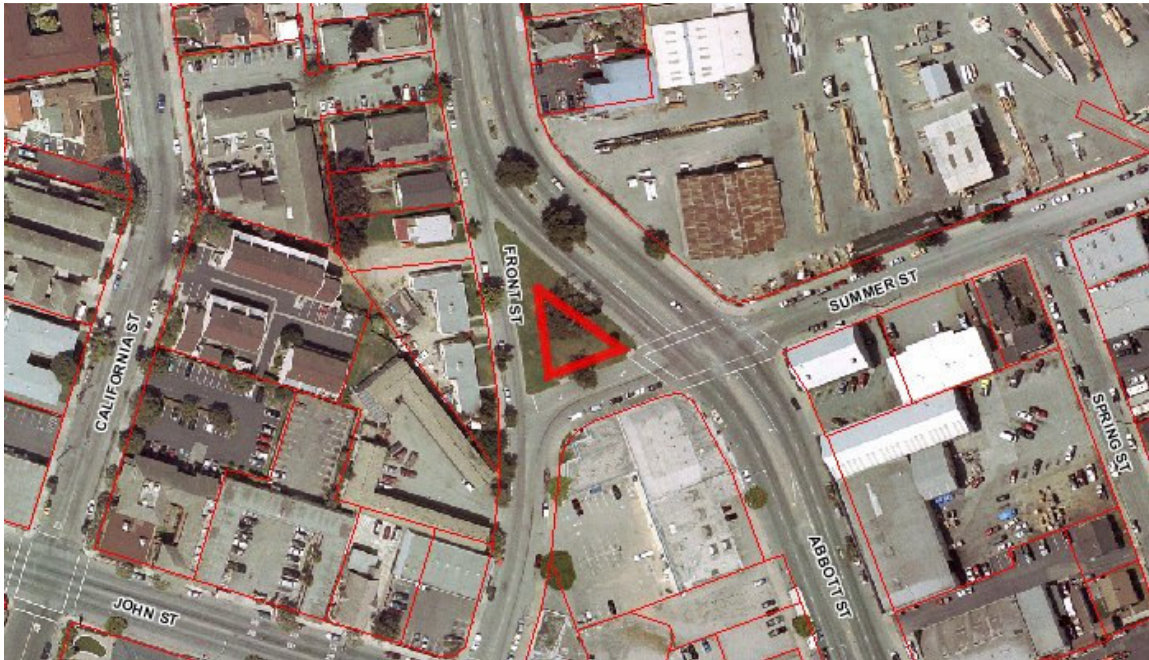
Cornell Corner is a .25-acre, irrigated turf median island between Abbot, Front, and Summer Streets, and has no facilities, structures, or recreational activity. The west side is residential and the other surrounding areas are commercial.

Potential site pollutants are minimal and include litter, trash, and herbicides. The site is level, completely permeable, and has no on site storm drains. Pollutants generated by park activity do not enter the storm water system.

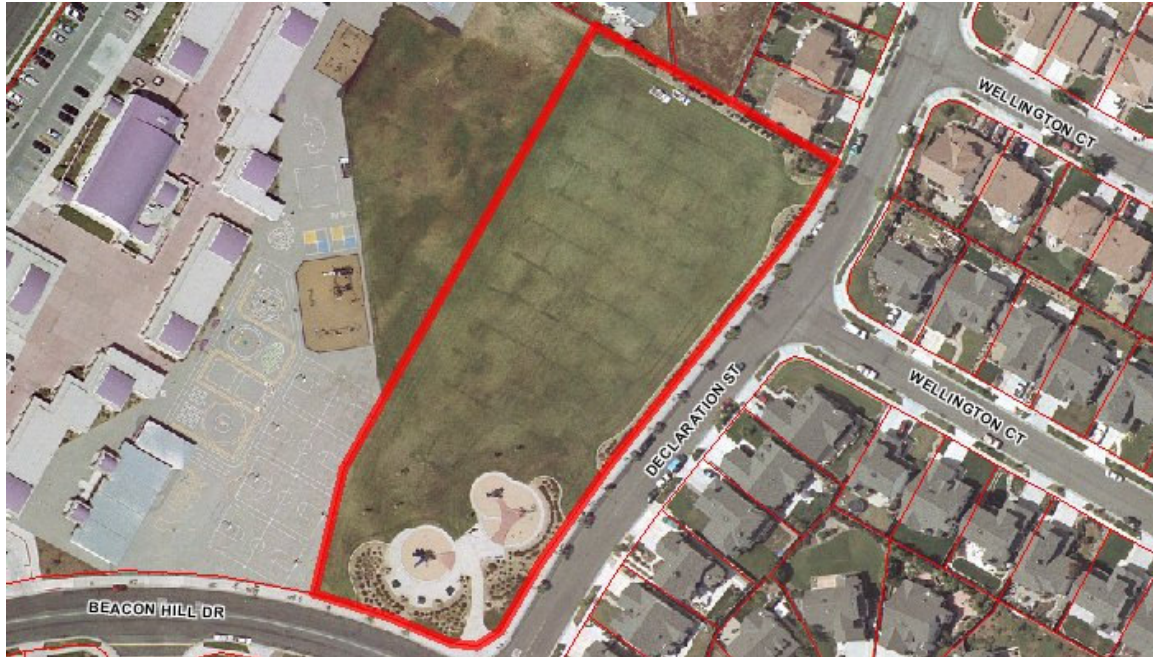
Creekbridge is a 2.5-acre park site including turf, landscape areas, two playgrounds, and a concrete picnic table pad adjacent to the playground. The park shares the west side with an elementary school and the other three sides are residential areas.

Potential site pollutants are sediment, nutrients, trash, bacteria, organics, pesticides, and oxygen demanding substances. These materials result from grounds or landscape maintenance and recreational day use. Creekbridge is approximately 4 % impervious surface, which drains to permeable turf, landscape, or playground areas. The small area of concrete around the playgrounds drains to the turf or to the corner of Declaration and Beacon Hill Drive, where it is directed to street drains. The hardscape area is clean and runoff contributes no significant pollutants of concern.

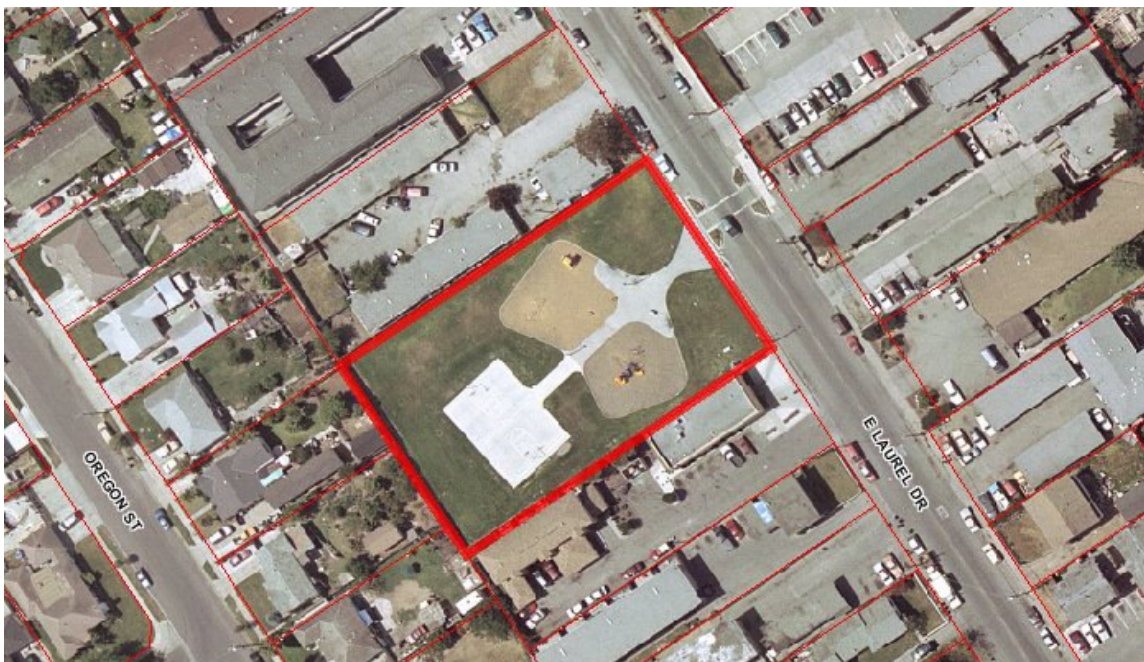
East Laurel Pocket Park is an .82-acre neighborhood park with a basketball court and concrete walkways. Residential areas border the west, south, and north side of the park. A business is located on the east.

Potential site pollutants are sediment, nutrients, trash, bacteria, organics, pesticides, and oxygen demanding substances. These materials result from grounds or landscape maintenance and recreational day use. The park is approximately 20 % impervious surface, including the basketball court and walkways. These areas drain to the surrounding permeable turf and playground areas. There are no on site storm drains, the park is level, and potential pollutants from park activities are confined to the site for percolation and do not impact the storm water system.

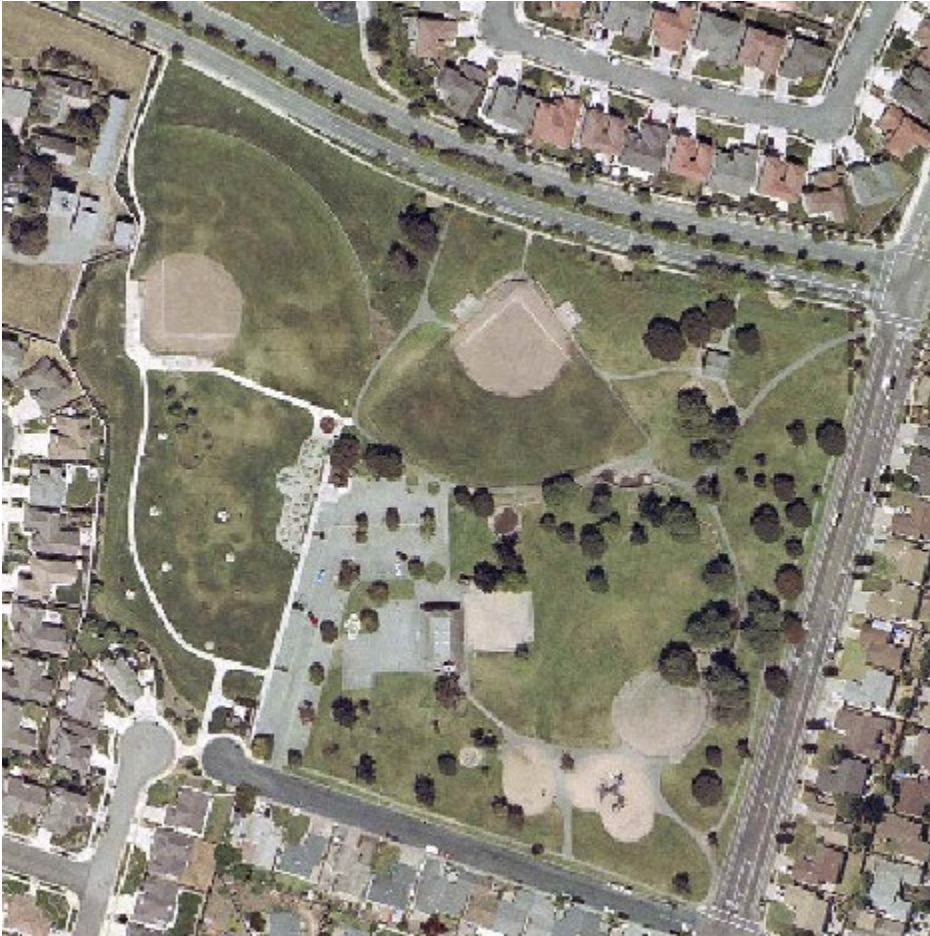
El Dorado Park is a 17-acre multiuse facility including two baseball fields, a basketball court, 3 playgrounds, two soil BBQ/picnic sites, one concrete BBQ/picnic site, one asphalt parking lot, one recreation building with adjacent patio, one maintenance building with attached restrooms, and one dumpster enclosure. The site also includes an asphalt creek and pond system that is not in use due to lack of a functioning discharge pump system. The creek system collects storm water and irrigation runoff. This water evaporates or percolates through permeable turf areas when pumped from the channel. The creek system has no open connection to the storm water system. The west parcel of the park has a detention basin planted with trees and natural grasses at the storm drain inlet. Residential lots surround the park

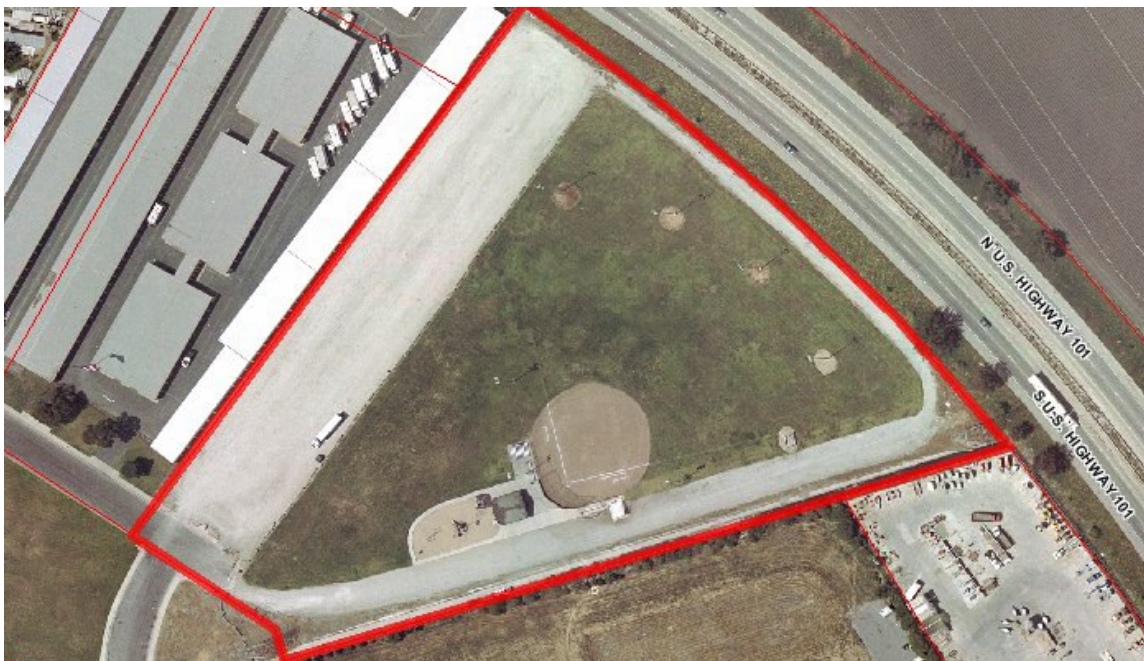
Expo/PGE site is owned by the California Rodeo Corporation and leased by the City of Salinas as a multiuse park with a baseball field, soccer fields, playground, and restroom/ maintenance building. The park is comprised of two parcels. The parcel number identifies the main Expo section, while the PG & E section has no parcel number. The Expo parcel includes the baseball field, building, playground, and DG parking area. The parking area is directly against the storage building walls along the entire west side of the parcel. The east side of the property is adjacent to a business zone. The north side is directly adjacent to an iceplant swale along the southbound lanes of Highway 101. The south end of this parcel connects with the PG & E parcel.

The Expo & PGE site is less than 5 % impervious surfacing, which includes the maintenance building and concrete pad, the paths around the playground, baseball-bleacher pads, and two small sections of City street at the park entrance. All of the surfaces except the asphalt street drain to adjacent, permeable turf, playgrounds, and compacted base roads and parking lots. The street sections drain to storm drains. A concrete-lined drainage ditch traverses the park from the southeast end of the parcel to the northeast along the east boundary. It is approximately 6 feet wide by 800 feet long, and carries road runoff water from Sun Way and Sun Streets. The drainage ditch exits the park site at the north boundary, flows under Highway 101, and enters Carr Lake and Reclamation Ditch # 1665.

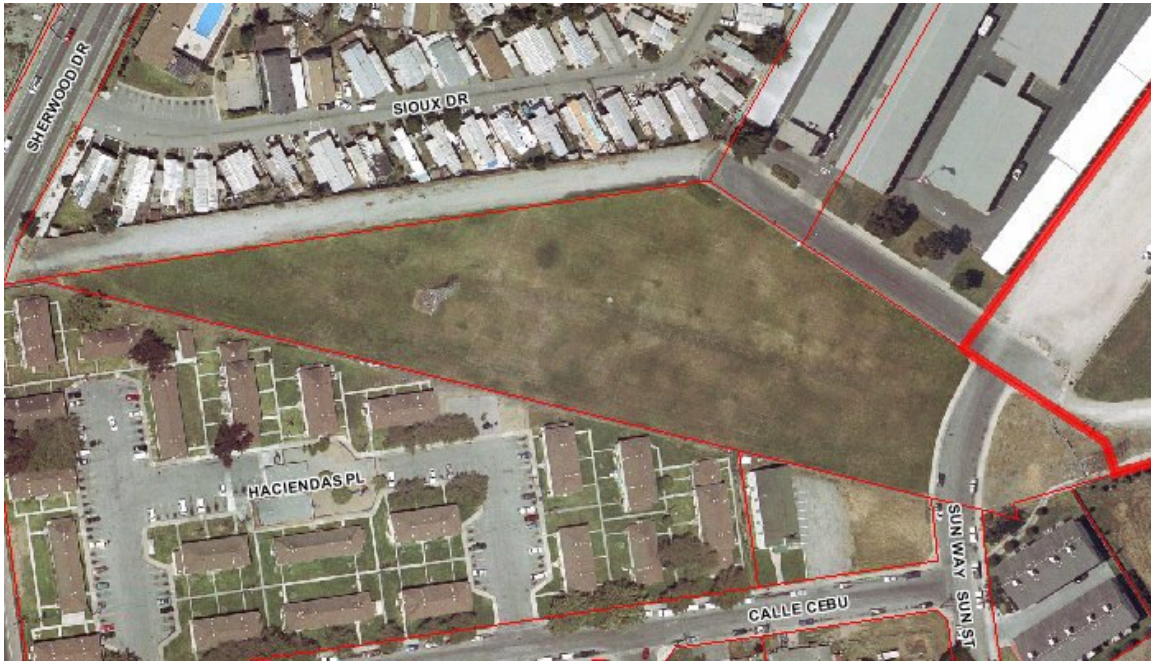
M016B EXPOSITION GROUNDS / P. G. & E. SITE

The PG & E site contains an easement for the existing high power electrical transmission lines and towers. This section is level, permeable turf used for soccer. It is adjacent to an open lot and apartments along the south fence line and by a DG road, trailer court, and Self Storage business on the north parcel. There is fenced irrigation control center located in an undeveloped dirt area at the east end.

The entire facility is used as a Carnival site during two weeks in July, in conjunction with the City of Salinas Rodeo. The Expo section is used for rides, attractions, and parking for transport equipment and employee vehicles and trailers. Potential pollutants of concern associated with the operation of the carnival include oils and grease, organics, trash, metals, bacteria, and oxygen demanding substances resulting from personnel living in vehicles at the site, animals in the carnival attractions, pets, fueling of generators, equipment, and vehicles, restroom facilities, and food vendors. The site is checked daily by Wastewater and/or Park personnel to ensure that all policies and procedures are being followed and there are no illegal discharges or sources of pollution that will contaminate the site. The P.G. & E. section of turf is used for carnival patron parking. All sites are required to be cleaned of debris, trash, and pollutants at the end of the carnival period. No irrigation is in operation during the event.

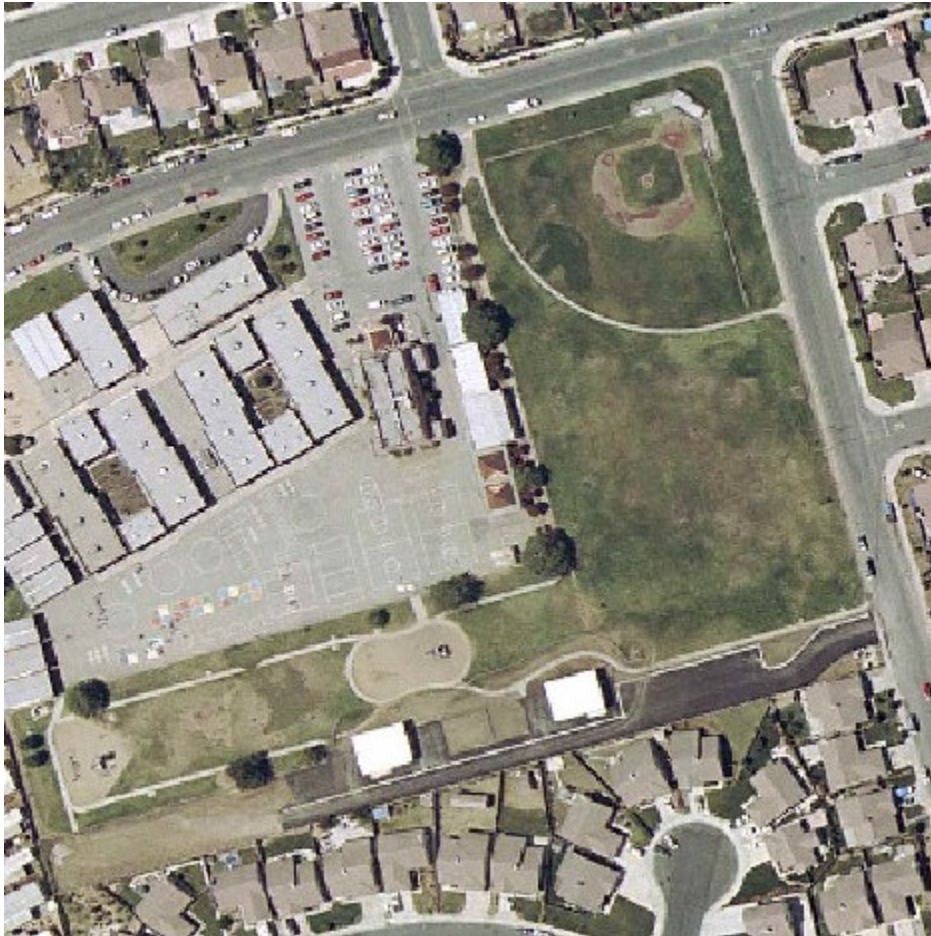
Frank Paul Park is on a parcel jointly owned by the City of Salinas and the Alisal Elementary School District. The park site consists of a baseball field with bleachers, two playground areas, and a turf area with a fitness par course. The north and east side of the park are on residential streets, while the west end is adjacent to a trailer park and the school. A day care center is on the south side.

Potential site pollutants are sediment, nutrients, trash, metals, bacteria, organics, pesticides, and oxygen demanding substances. These materials result from grounds or landscape maintenance, and recreational day use. The park is less than 10 % impervious surfacing, consisting of concrete paths that drain to permeable landscape, turf, and playground surfaces. The park is level and has no on-site storm drains.

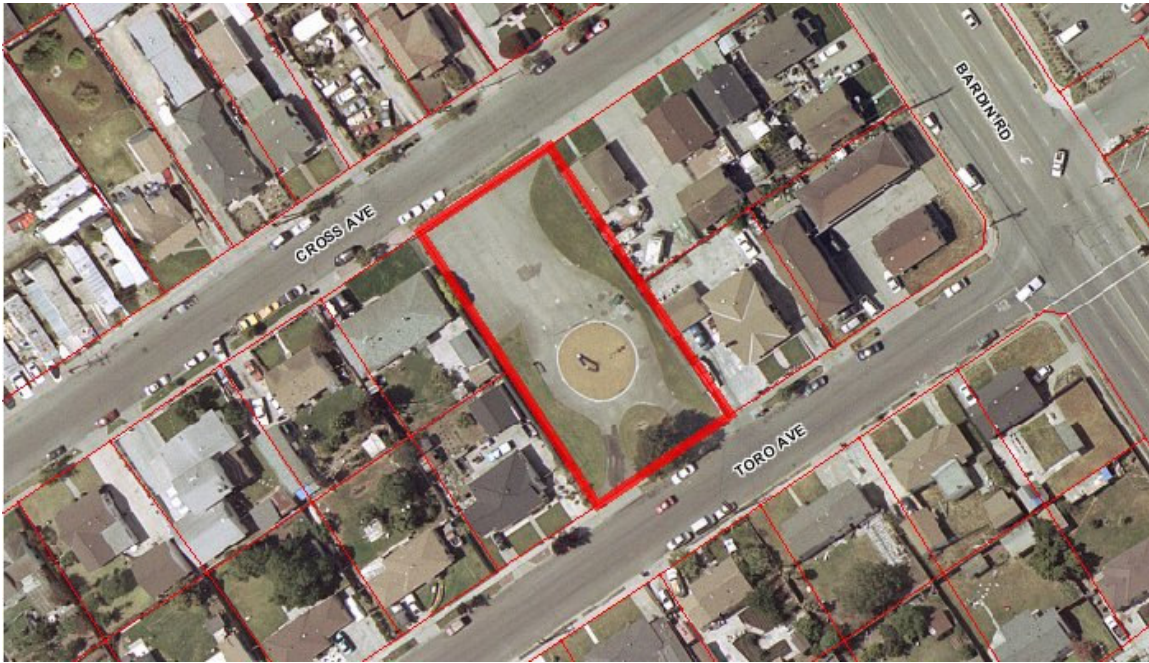
Gabilan Tot Lot is a .46-acre neighborhood park with one playground, an asphalt game court, and minimal turf. The property is surrounded by residential sites.

Potential site pollutants are sediment, nutrients, trash, bacteria, organics, pesticides, and oxygen demanding substances. These materials result from grounds or landscape maintenance and recreational day use. The site is approximately 58 % impervious surface, most of which drains to adjacent permeable playground and turf areas. There are no storm drains on site and the park is level. Some drainage on the north side flows to the sidewalk and into a permeable turf parking strip. Pollutants generated by park activity do not enter the storm water system.
